Quarterly Monitoring Report

Universal Oil Products (UOP) Site

East Rutherford, NJ

March 2007

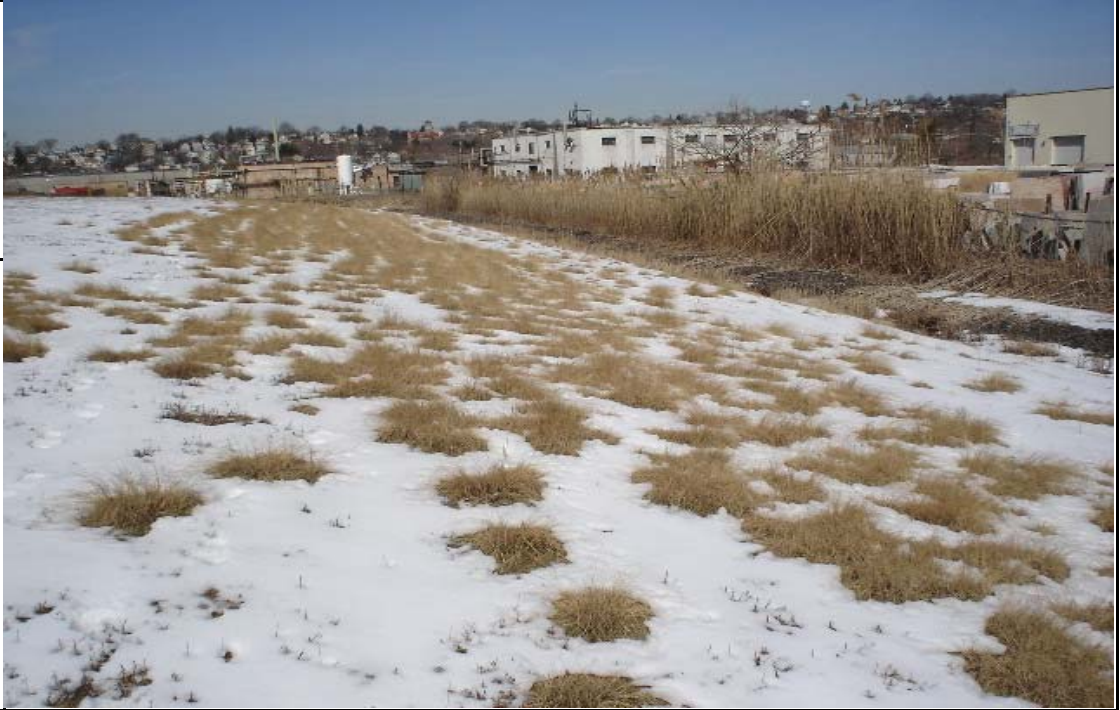
Photo No. | Date:
7 | 03/21/07

Description:
North half of GCL
Cap System looking
West

Action Needed:
None

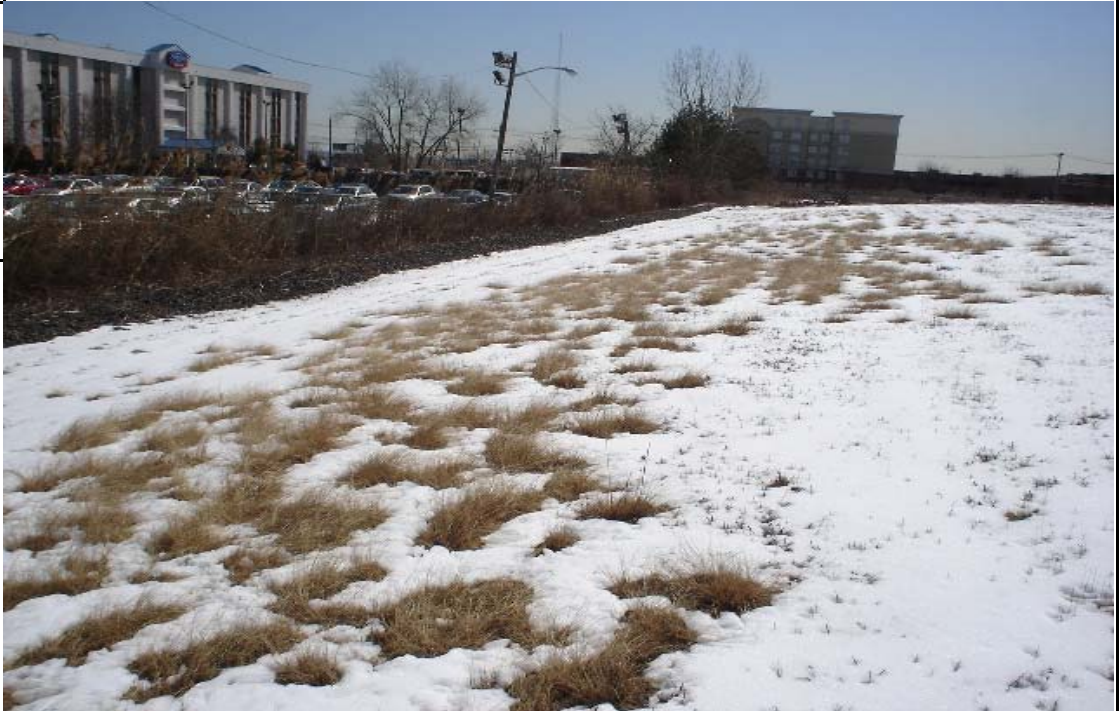
Photo No. | Date:
8 | 03/21/07

Description:
North half of GCL
Cap System looking
East

Action Needed:
None

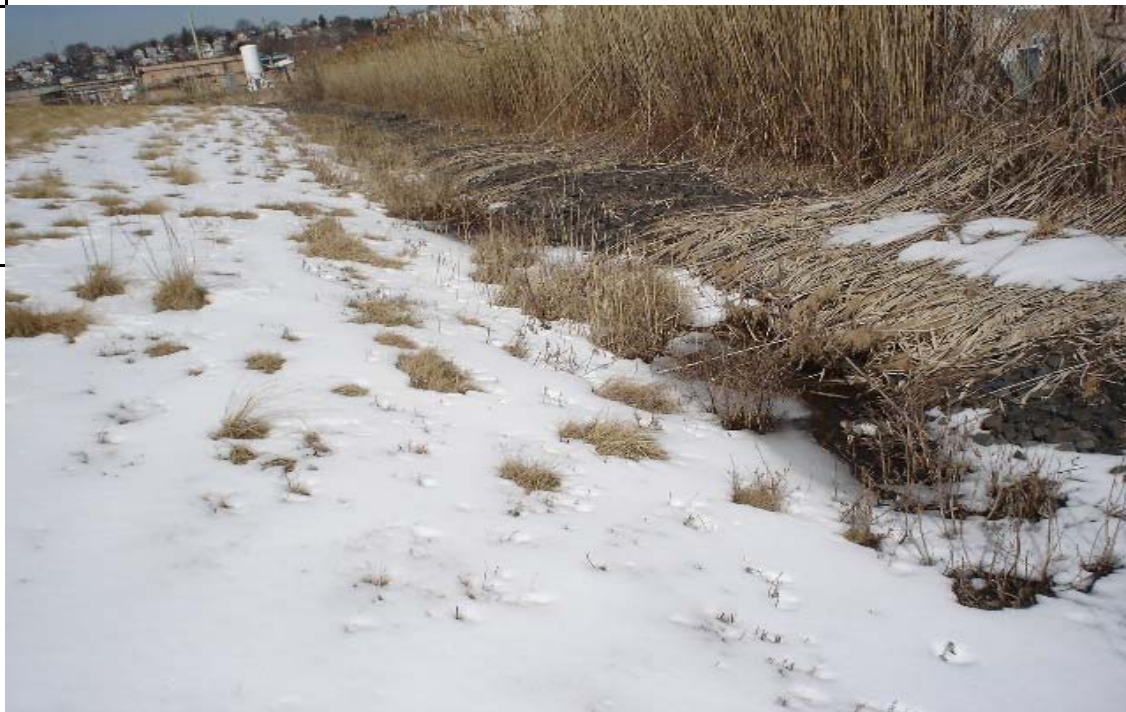
Photo No. | Date:
9 | 03/21/07

The stormwater swales are generally in good condition, however; the Northwestern portion of the swale is starting to show evidence of ponding water. This ponding water may be caused by the melting snow and vegetation that grows in this area. The ponding water previously showed signs of a reddish color and an oily type sheen floating on top, but that was not noted during the latest inspection.

Description:
North half of GCL
Cap System looking
West; ponding water

Action Needed:
None

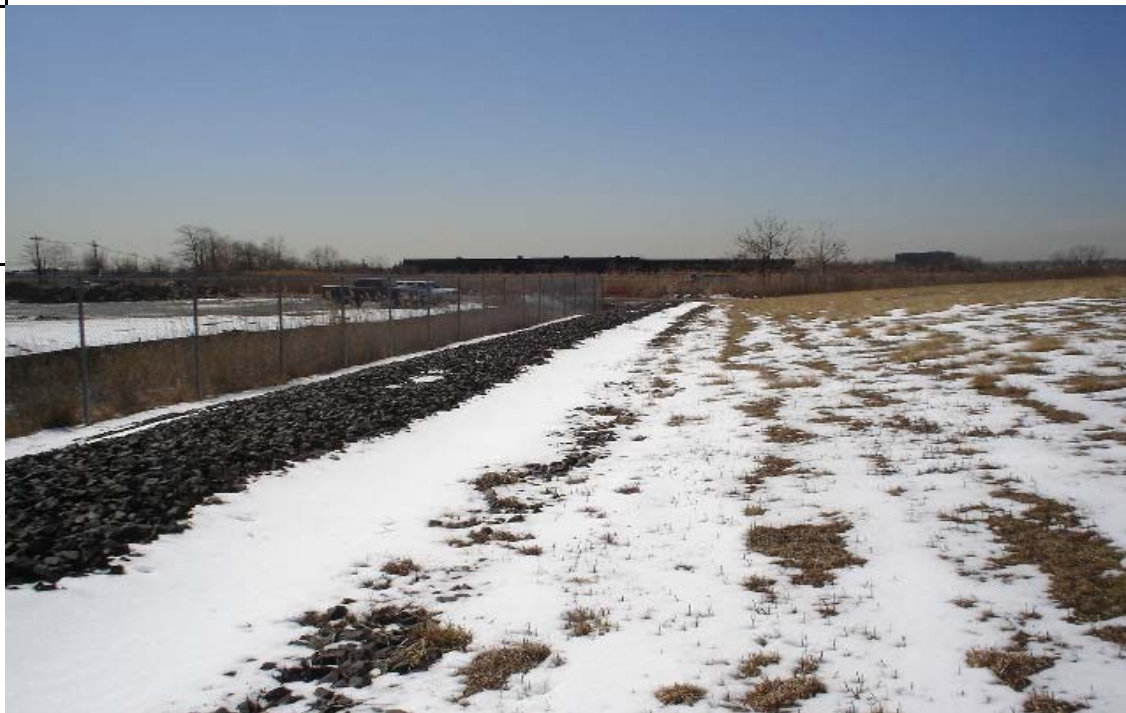
Photo No. | Date:
10 | 03/21/07

Description:
East half of GCL
Cap System looking
South

Action Needed:
None

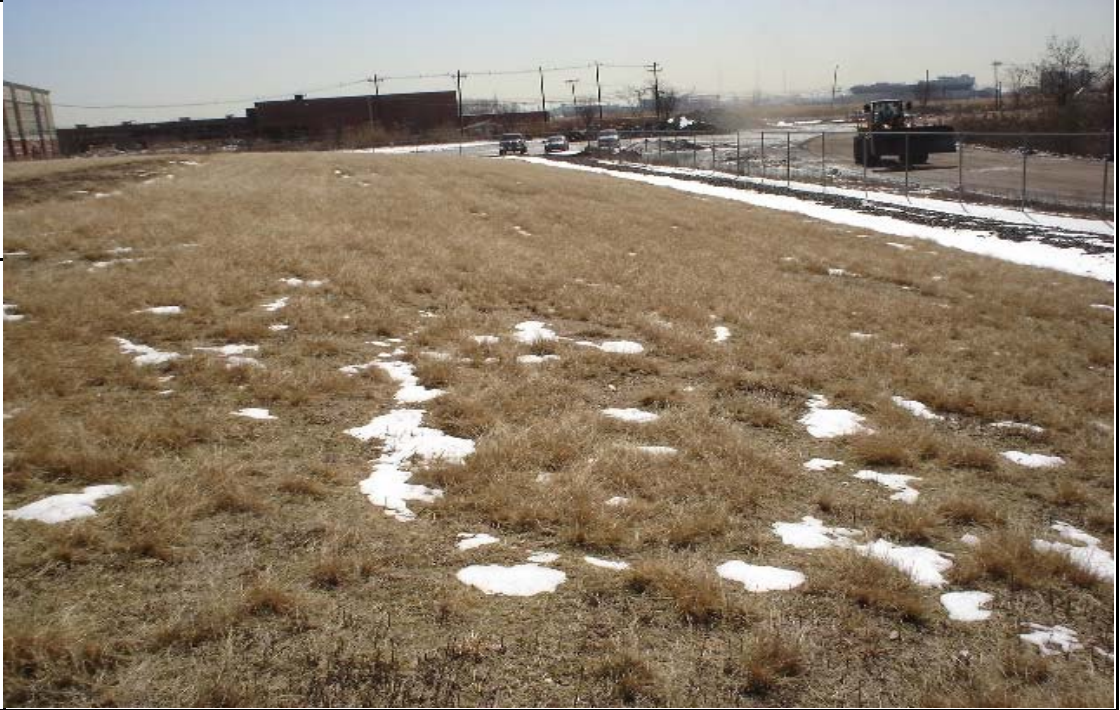
Photo No. | Date:
11 | 03/21/07

Description:
South half of GCL
Cap System looking
East

Action Needed:
None

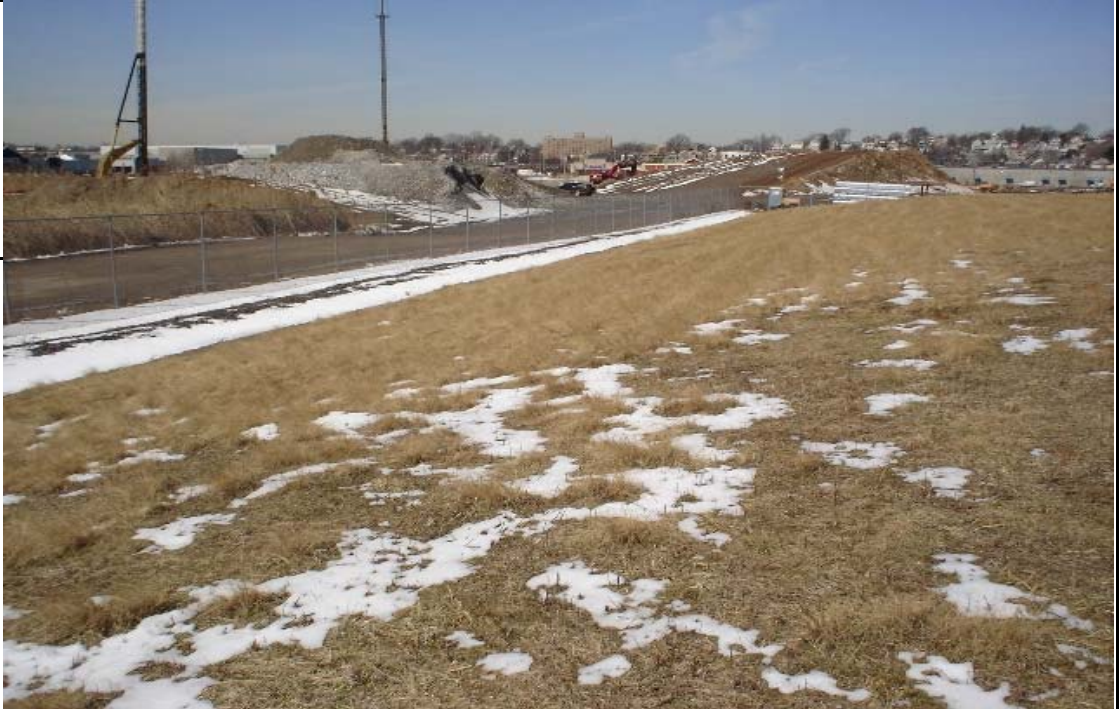
Photo No. | Date:
12 | 03/21/07

Description:
South half of GCL
Cap System looking
West

Action Needed:
None

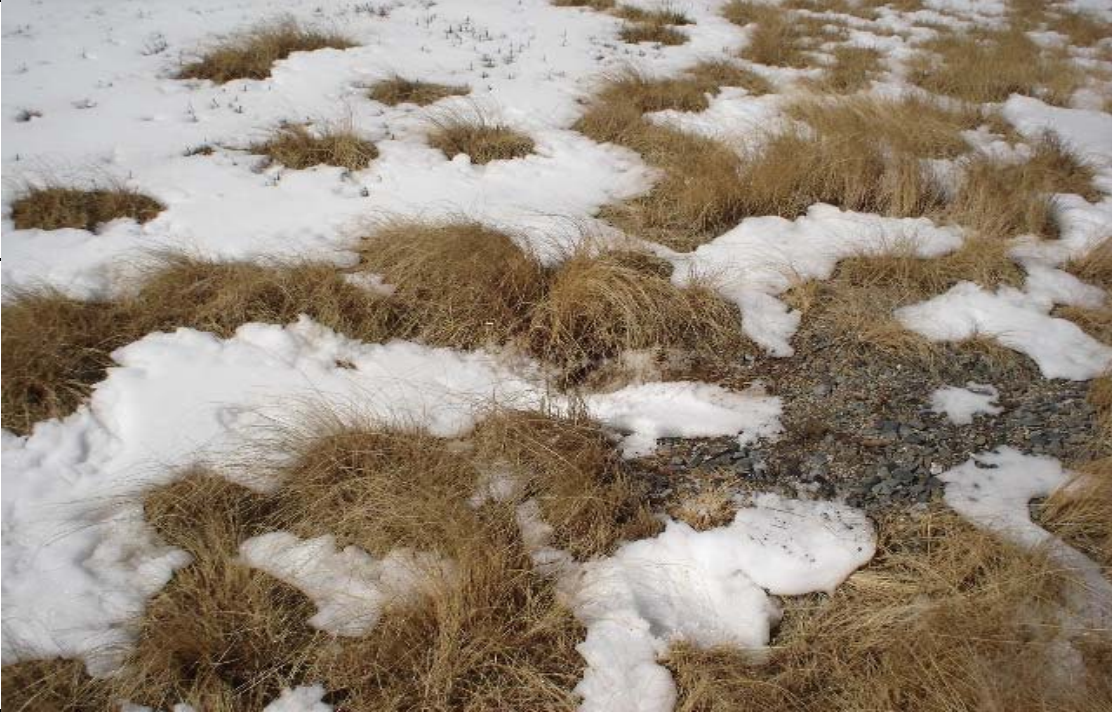
Three rodent holes were identified within the soil cover of the GCL permanent cap during the March 2007 inspection. These holes will be filled in with stone during the 2nd quarter 2007 inspection.

A close-up photograph of a field covered in patches of snow and dry, yellowish-brown grass. Several small, dark holes, likely made by groundhogs, are visible in the snow.	
Description: Groundhog holes in Northwest side of GCL Cap System			
Action Needed: Rodent controls			
Photo No. 14	Date: 03/21/07

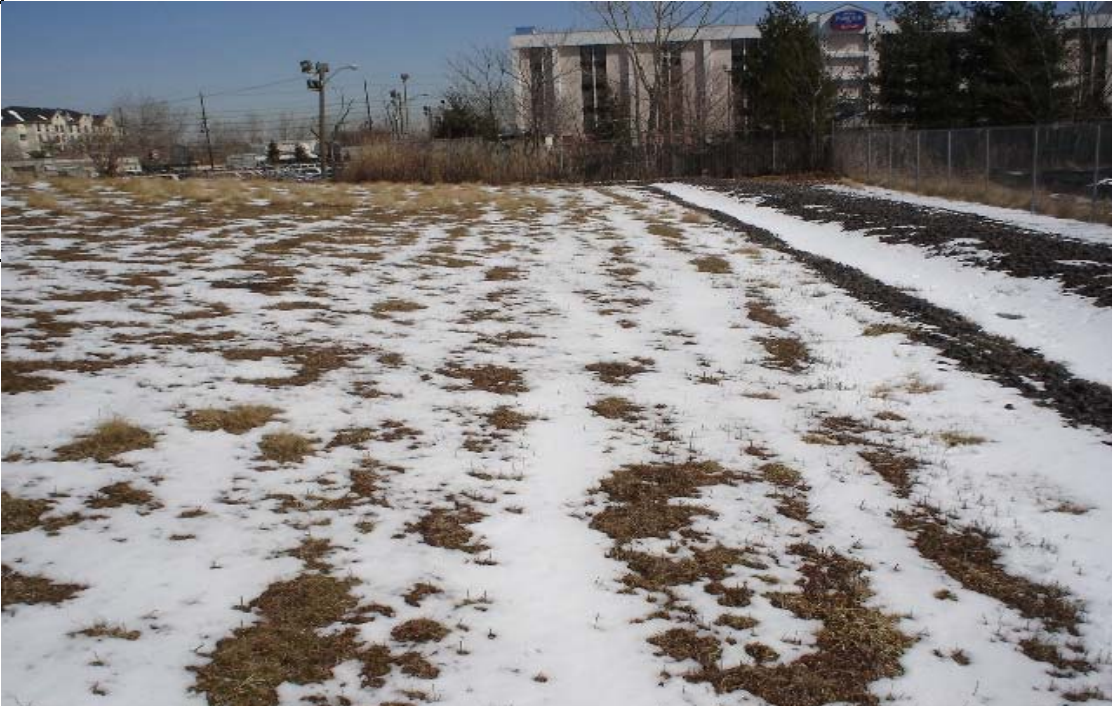
A wide-angle photograph of a large, flat area covered in snow and patches of dry grass. In the background, there is a chain-link fence, some trees, and a large, multi-story building with a flat roof.	
Description: Eastern side GCL Cap System looking North			
Action Needed: None

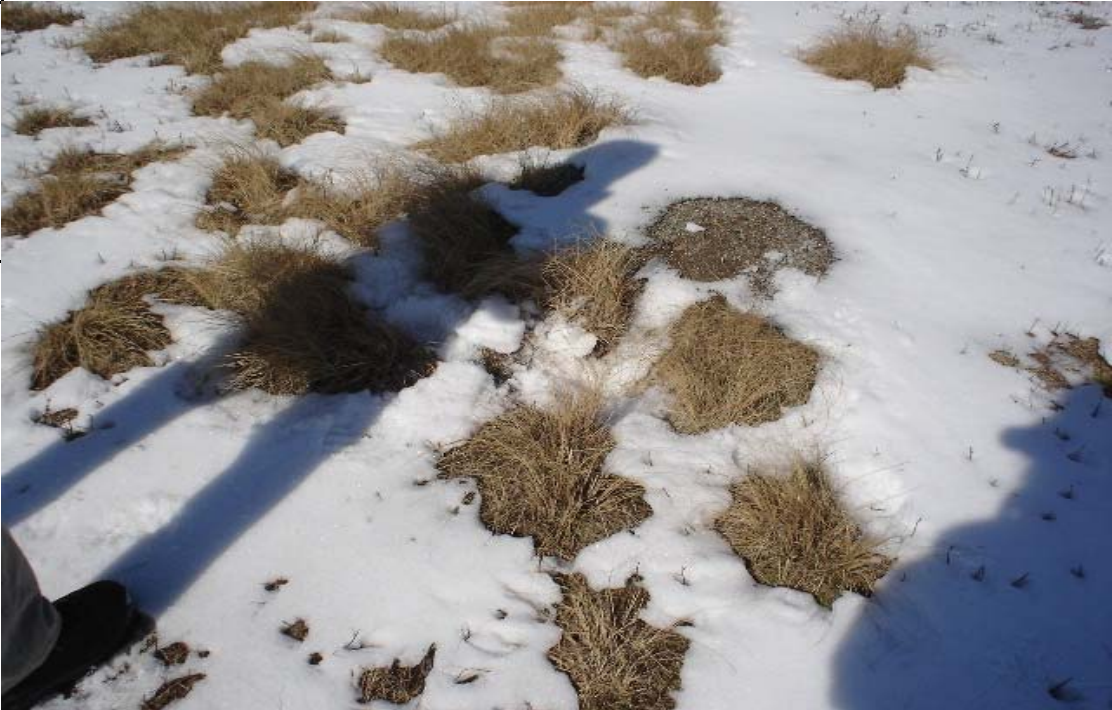
A photograph showing a snowy field with several groundhog holes. The holes are dark, irregular shapes in the snow, surrounded by patches of dry, brown grass. A long shadow is cast across the snow from the left.	
Description: Groundhog holes in West side of GCL Cap System			
Action Needed: Rodent controls			
Photo No. 16	Date: 03/21/07

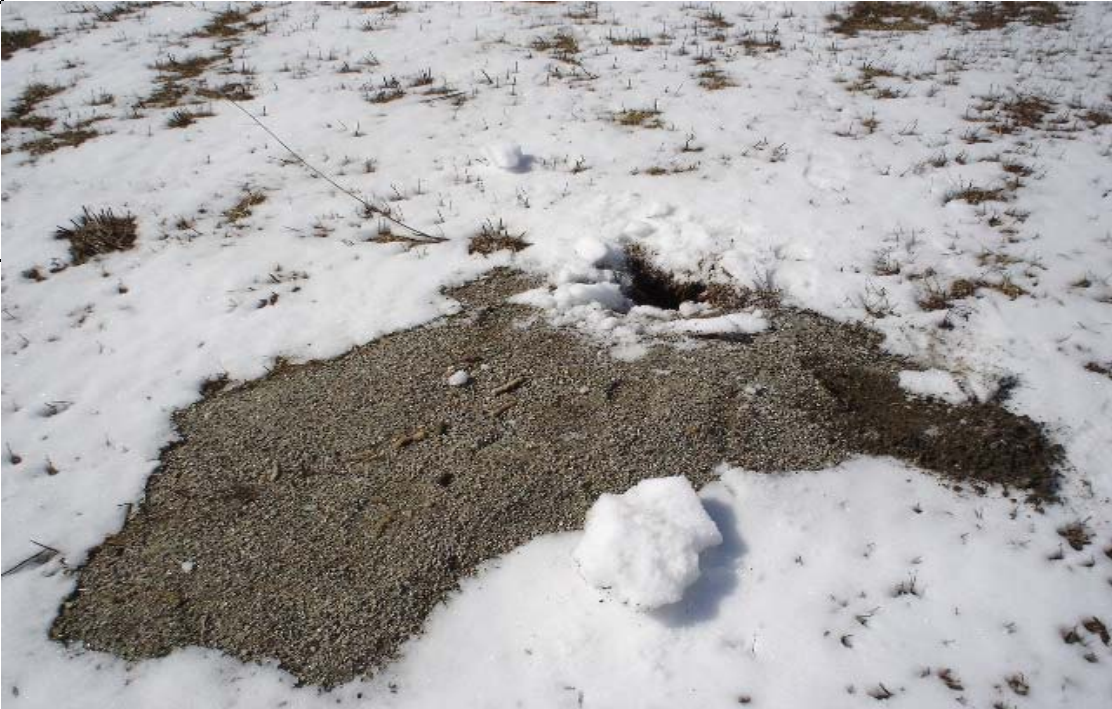
A close-up photograph of a groundhog hole in the snow. The hole is a dark, irregular shape, and the surrounding snow is disturbed, showing a mix of dark soil and light-colored snow. A small, white, snow-covered object is visible in the foreground.	
Description: Groundhog holes in West side of GCL Cap System			
Action Needed: Rodent controls
